Final
Report

CR 134269

Flight Prototype Regenerative Particulate Filter System Development

Contract NAS9-12685
DRL Number T-744
DRL Line Item 4
DRD Number MA-183T
MCR-74-52

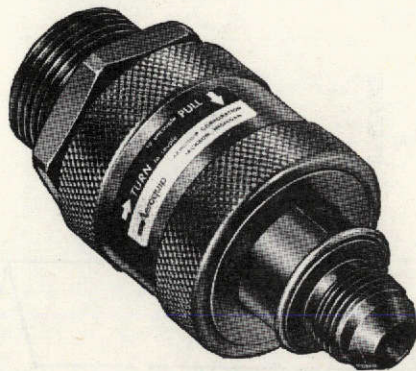
Figure IV-13 Quick Disconnect Coupling

5. Fluid Quick Disconnects - The fluid quick disconnects permit connection and disconnection of the secondary and regenerative filters to the regeneration unit without loss of system fluid or pressure. The self-sealing quick disconnects are designed for $20.682 \times 10^6 \text{ N/m}^2$ (3000 psig) maximum pressure and easily connect and disconnect with one hand. Figure IV-13 shows an external view of the quick disconnect coupling with the "TURN" to connect "PULL" to disconnect markings. The quick disconnect coupling, Figure IV-14, consists of two parts: the nipple half which is connected to the regenerative and secondary filters; and the coupler half which is connected to the regeneration unit fluid lines. When these two halves are separated, the valves are closed and the "O" rings provide an unexposed and fully protected seal. When connecting, the coupling halves align and mate without a cavity thereby preventing air entrapment on connection or fluid spillage on disconnection.
